NPL Report MATC(A)164

Crack Detection Methods For Lead-free Solder Joints

Milos Dusek & Christopher Hunt

March 2004

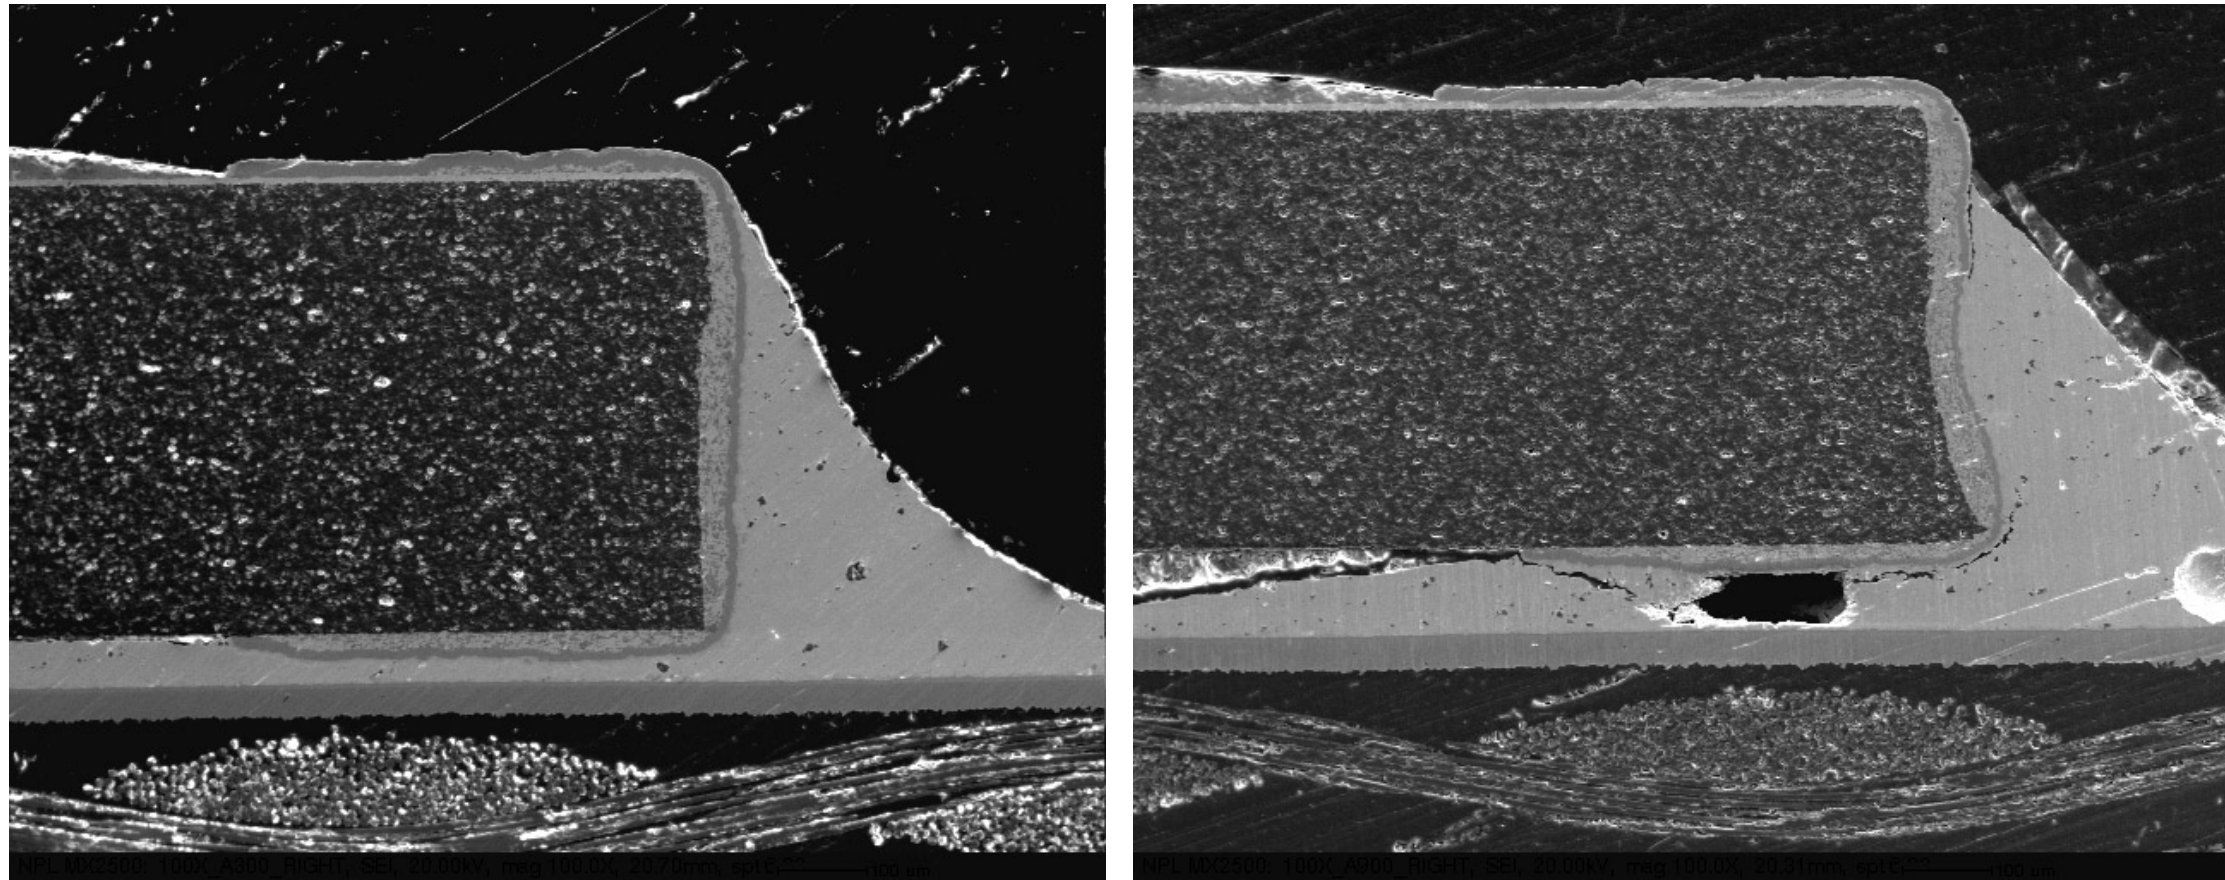
Figure 4. Microsections of 2512-type resistor solder joints without a crack (300 cycles - left) and cracked (900 cycles - right). The images were taken in the SEM secondary electron mode

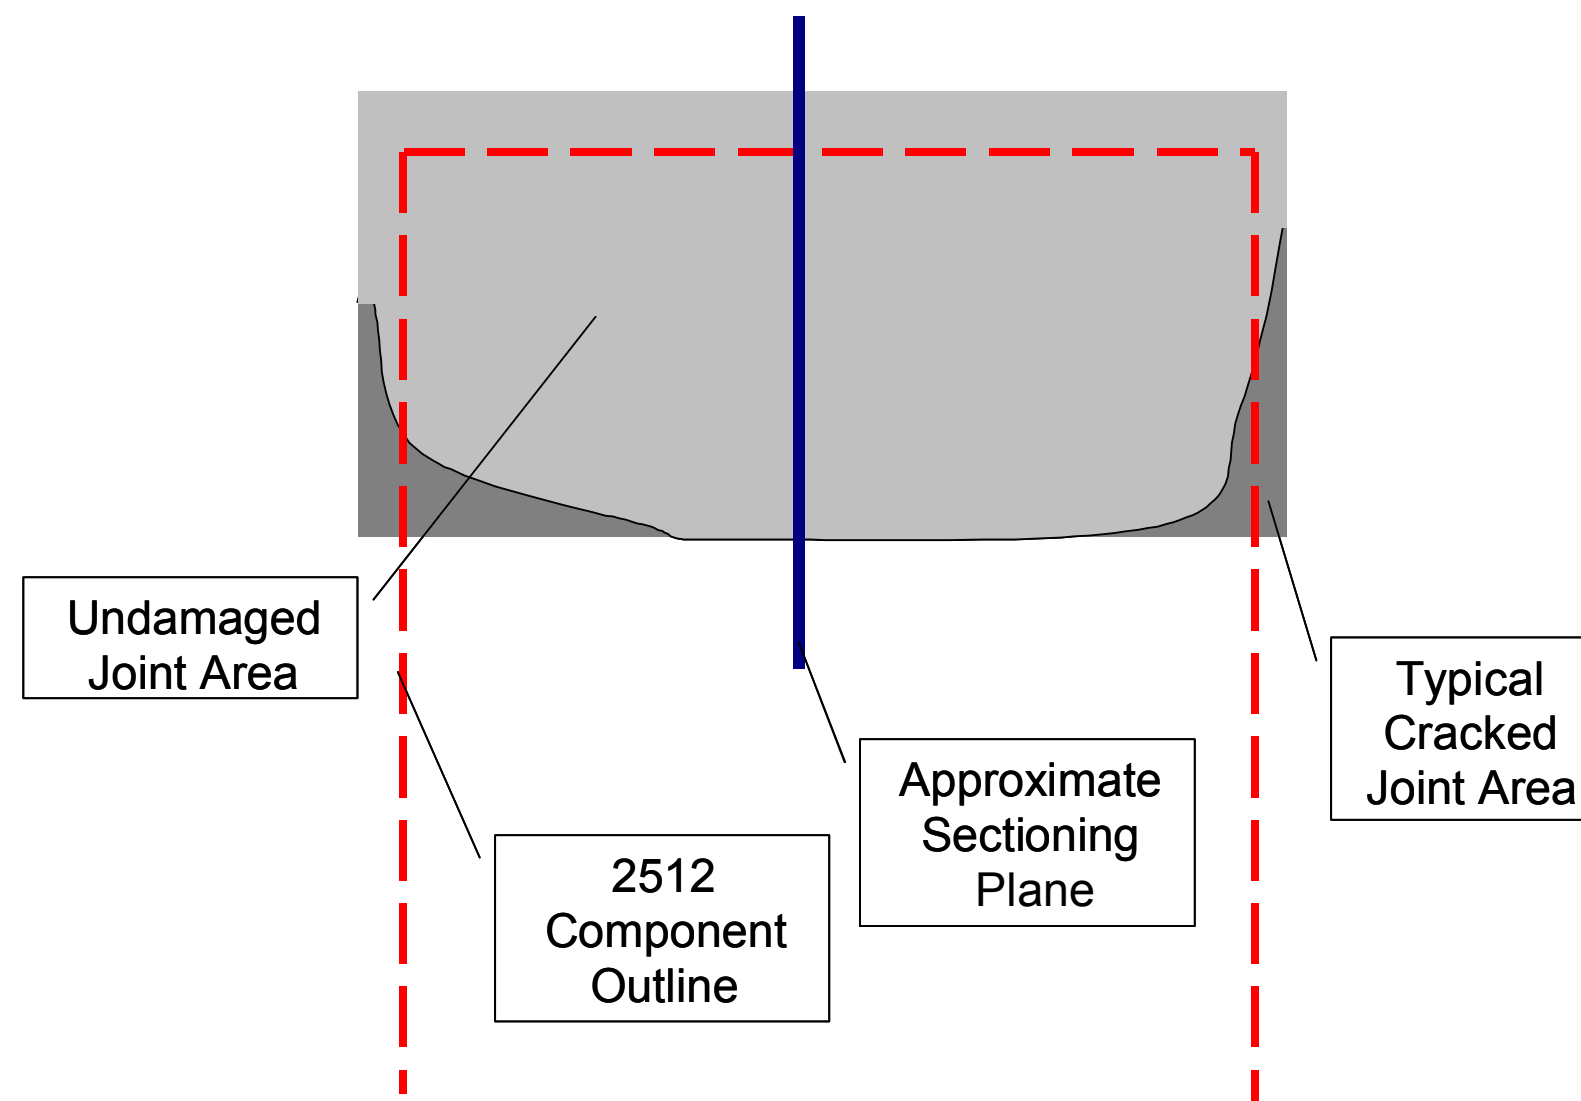
Figure 5. Central sectioning point shows the microstructure, but not developing corner cracks.

It should be noted that whilst the micro-sectioning technique is suitable for the assessment of the failure mode, it can be misleading for quantitative evaluation of crack growth in the solder joints. This is illustrated in Figure 5, which shows the location of cracked joint areas with reference to a mid plane between the ends of the component. If the latter happens to be the cross-sectional plane none of the cracked area would be visible in the microsection. Hence to ensure crack detection the cross-sectional plane should be close to the component outline. Unfortunately with small component sizes, such as 0805-type resistors, this may be difficult to achieve.

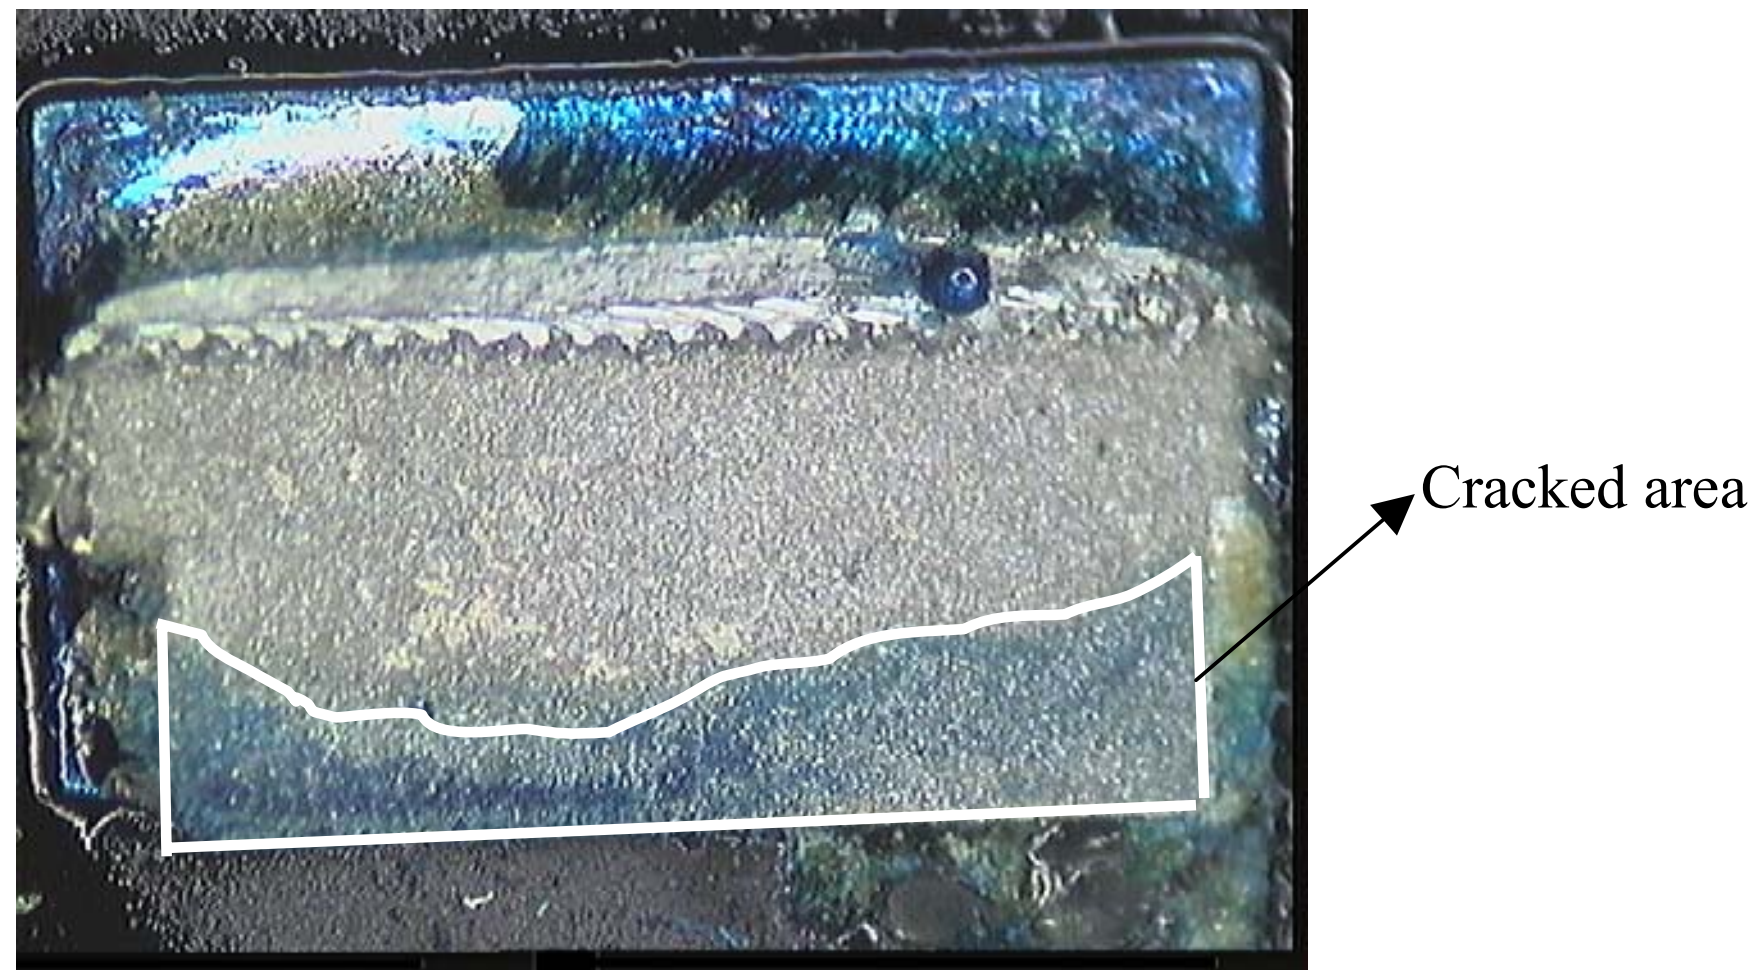
Figure 6. Crack in a SnAgCu solder joint after thermal cycling.

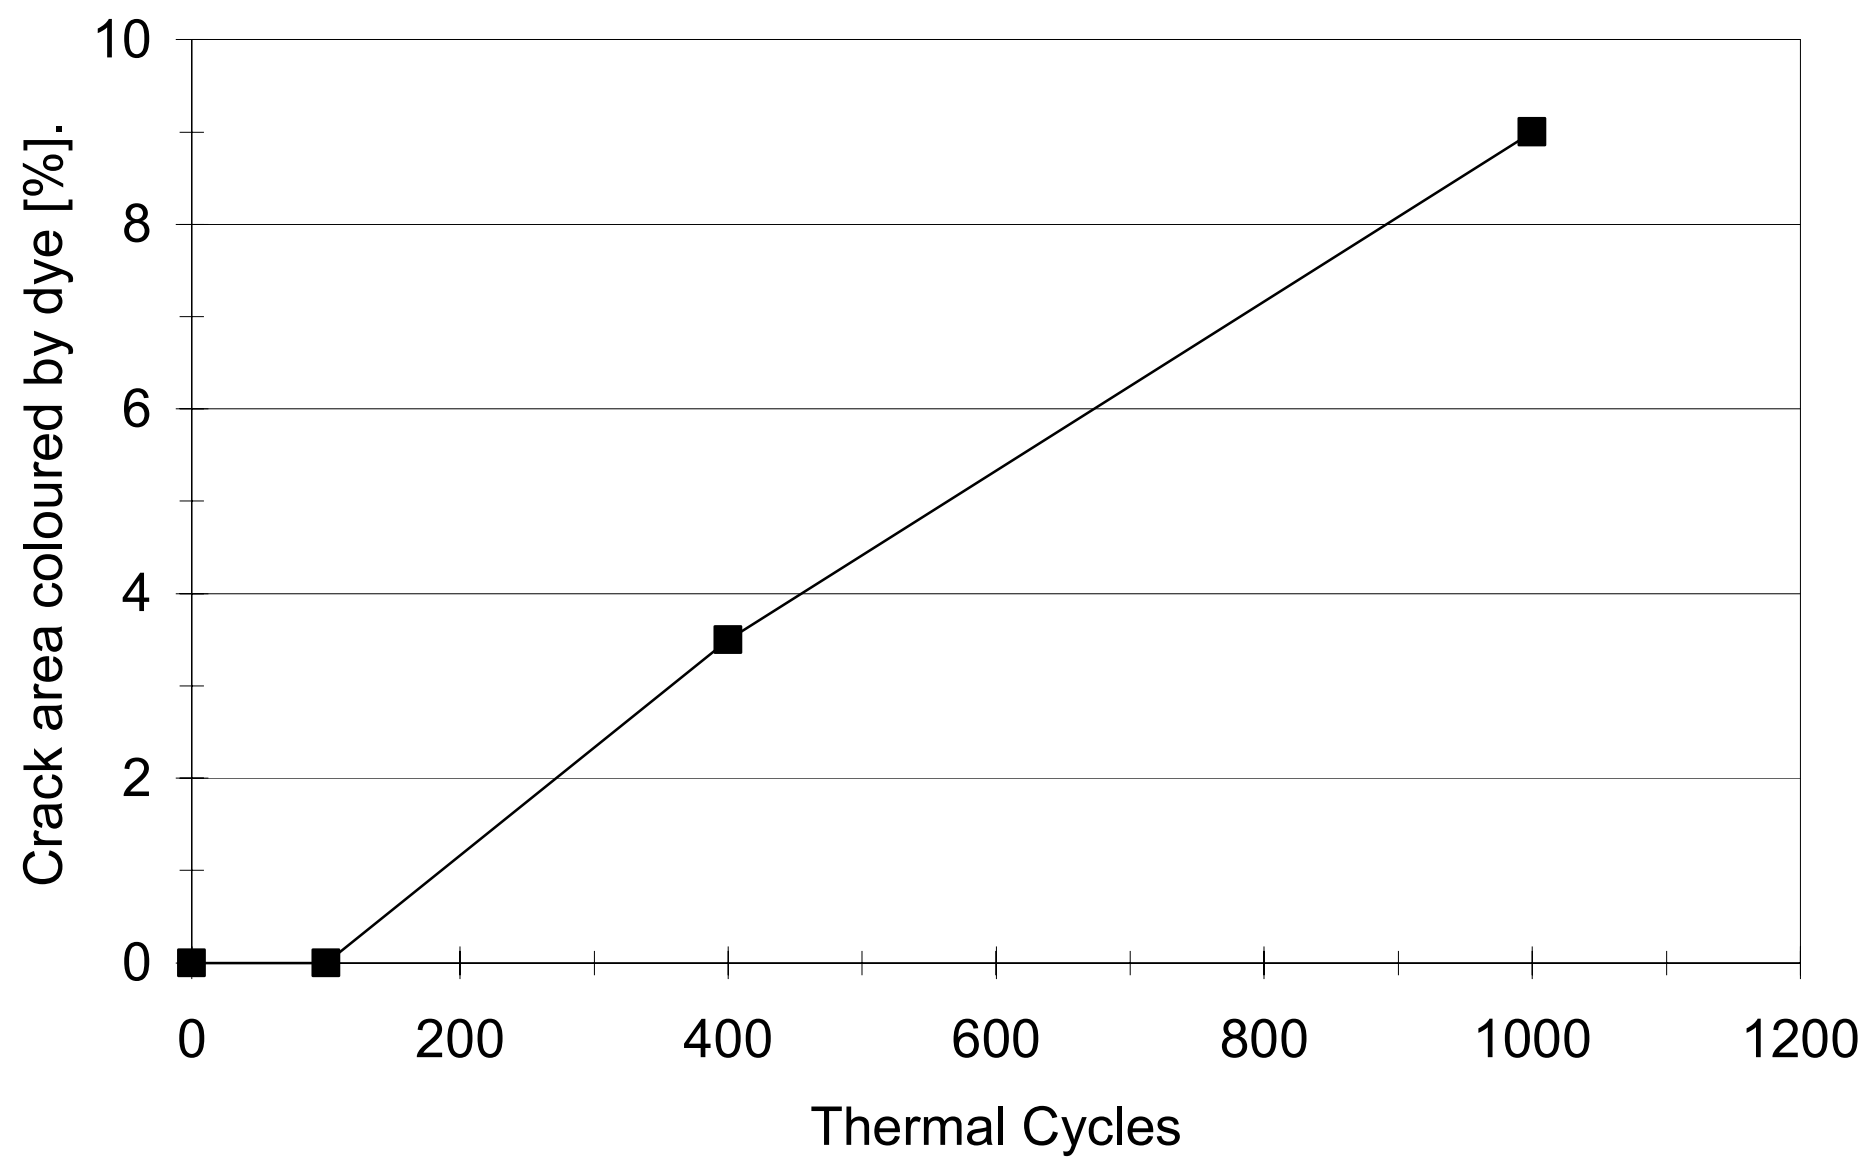
The crack area growth in terms of the number of cycles was evaluated by measuring the number of pixels in the appropriate part of the image, and the results are presented in Figure 7. Since this method gives more quantitative results than does micro-sectioning, it can be used for assessment of non-cracked area i.e. to study the stress acting on a solder joint, and to analyze the whole area of a crack. It is not dependent on the positioning of the cross-sectional plane, as is the case with micro-sectioning.

Figure 7. Percentage of cracked area under 2512-type resistors as a function of the number of thermal cycles, for SnAgCu solder

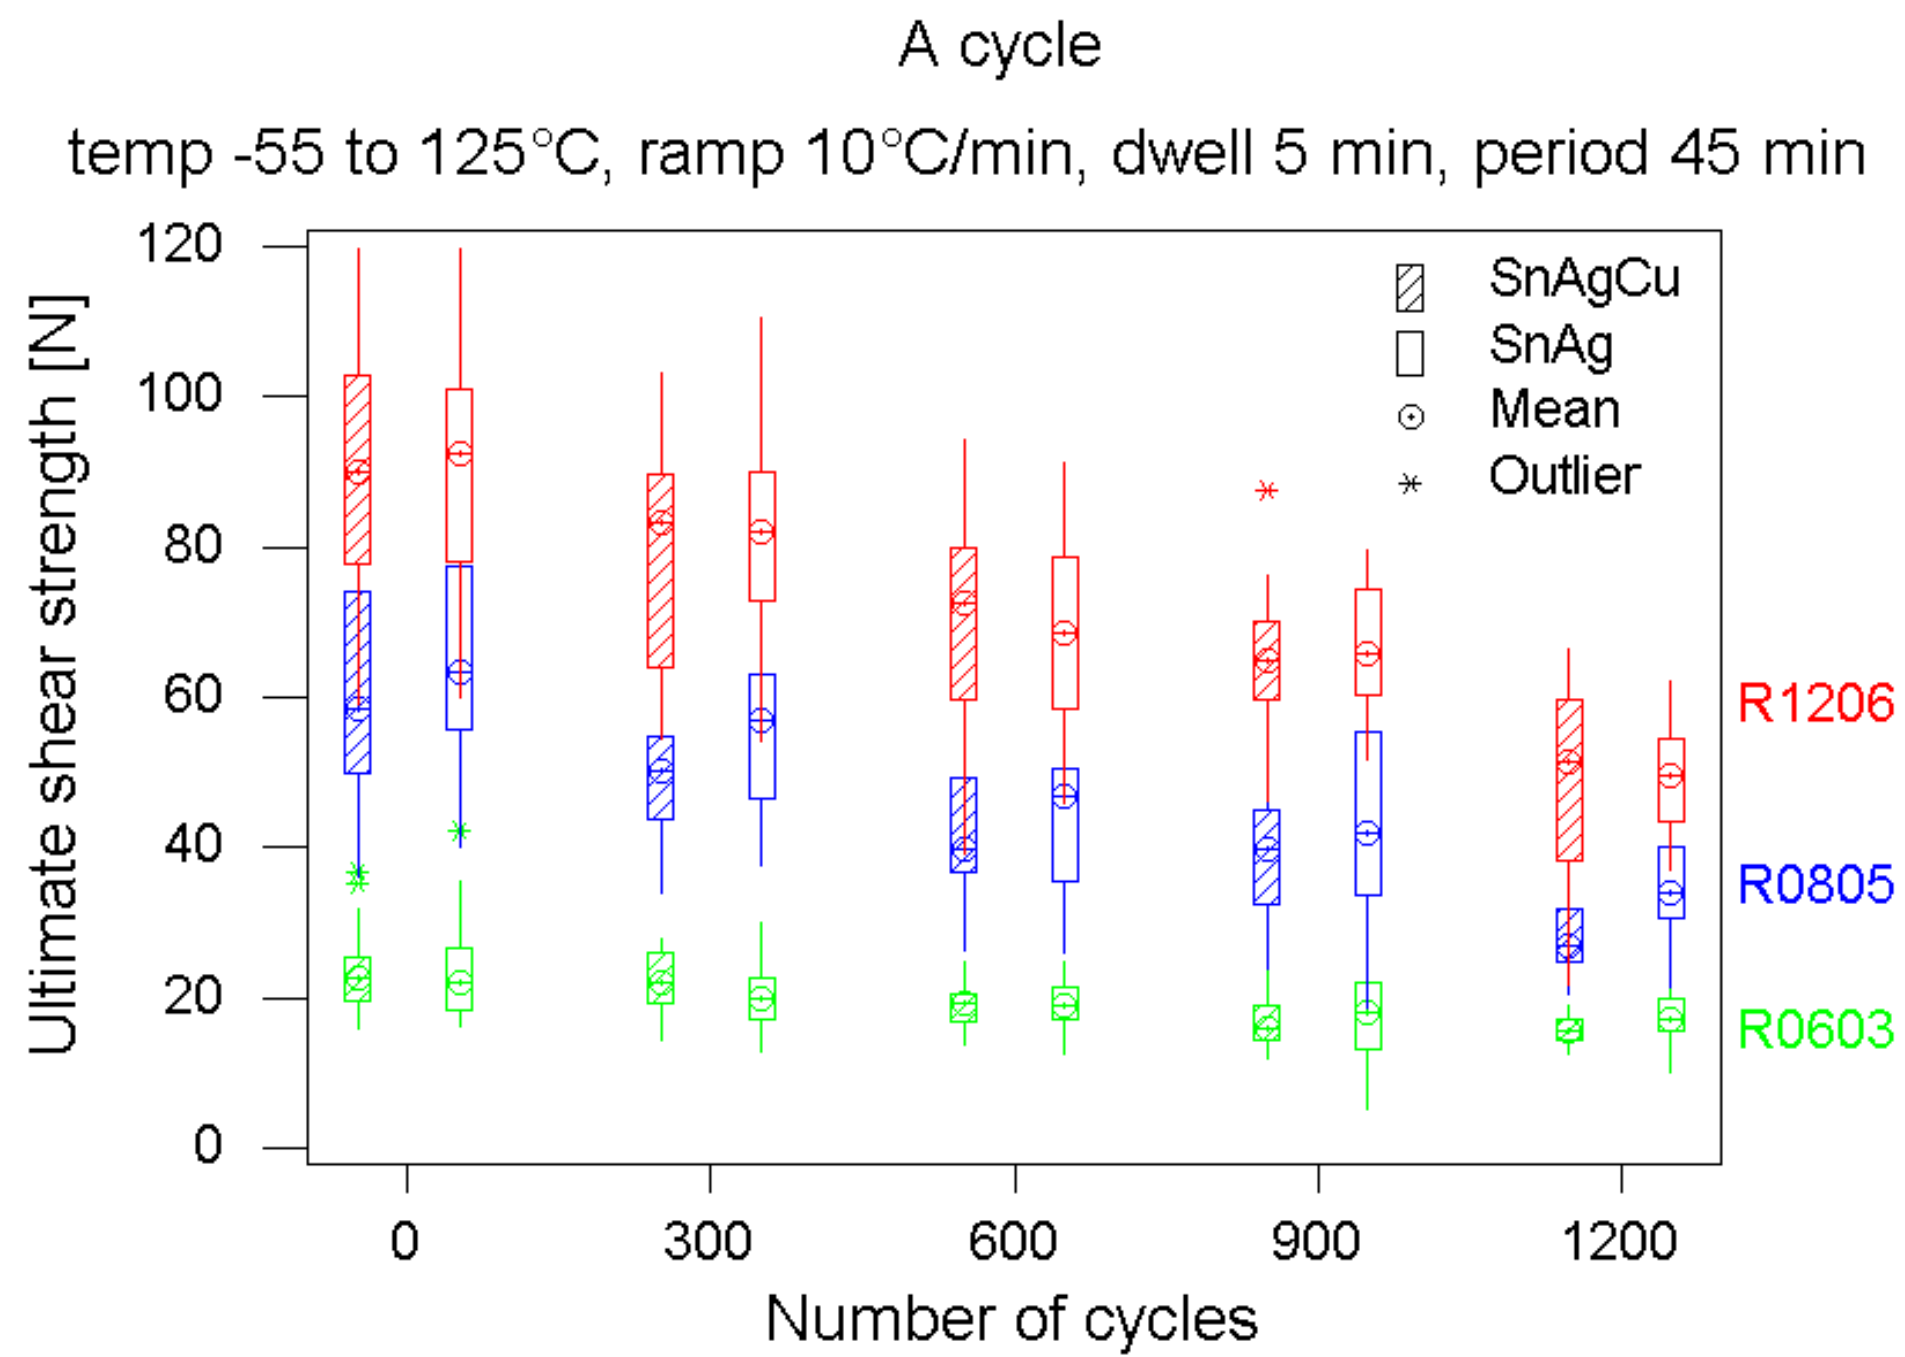
The data obtained in the test were analysed in terms of the ultimate shear force required to rupture the solder joint, and then plotted as a function of the number of thermal cycles to which the assembly had been subjected. An average value was calculated from the 26 individual measurements and plotted together with the first and third quartile of a box-whisker diagram shown in Figures 10.

Figure 10. Shear testing results for 3 sizes of chip resistor.

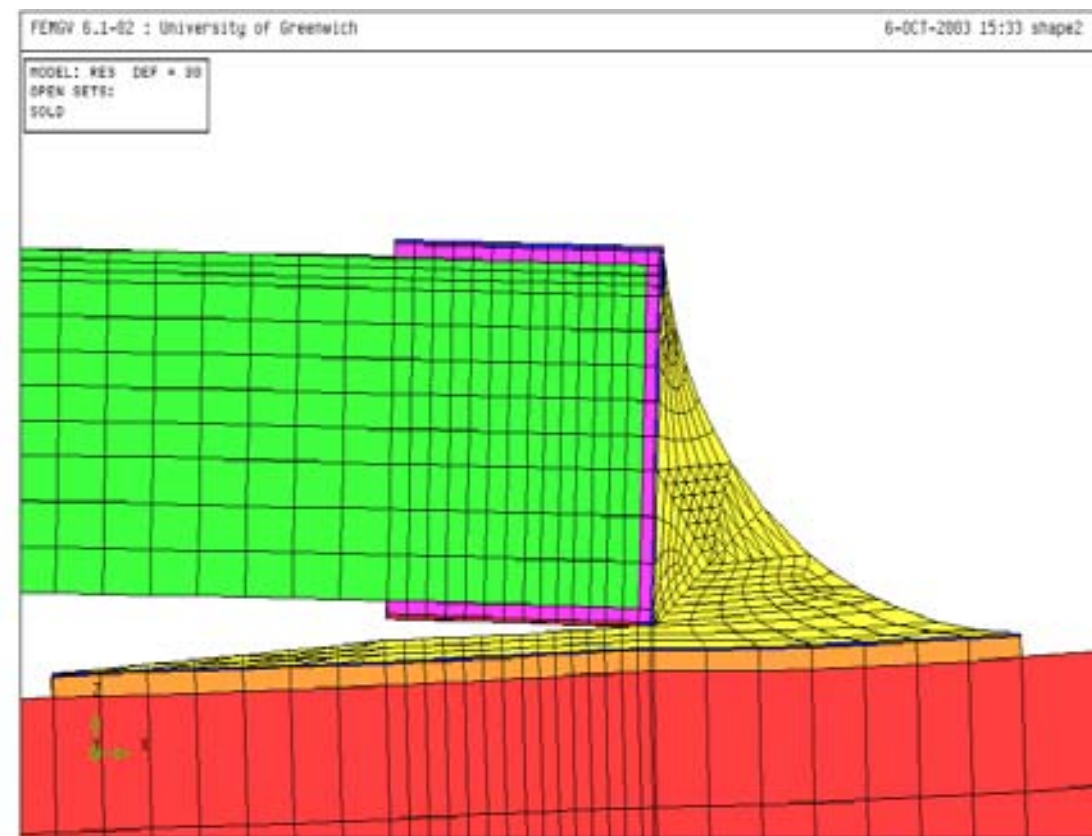
Figure 22. FEA model showing how applied deformation opens a solder joint crack under the resistor termination.

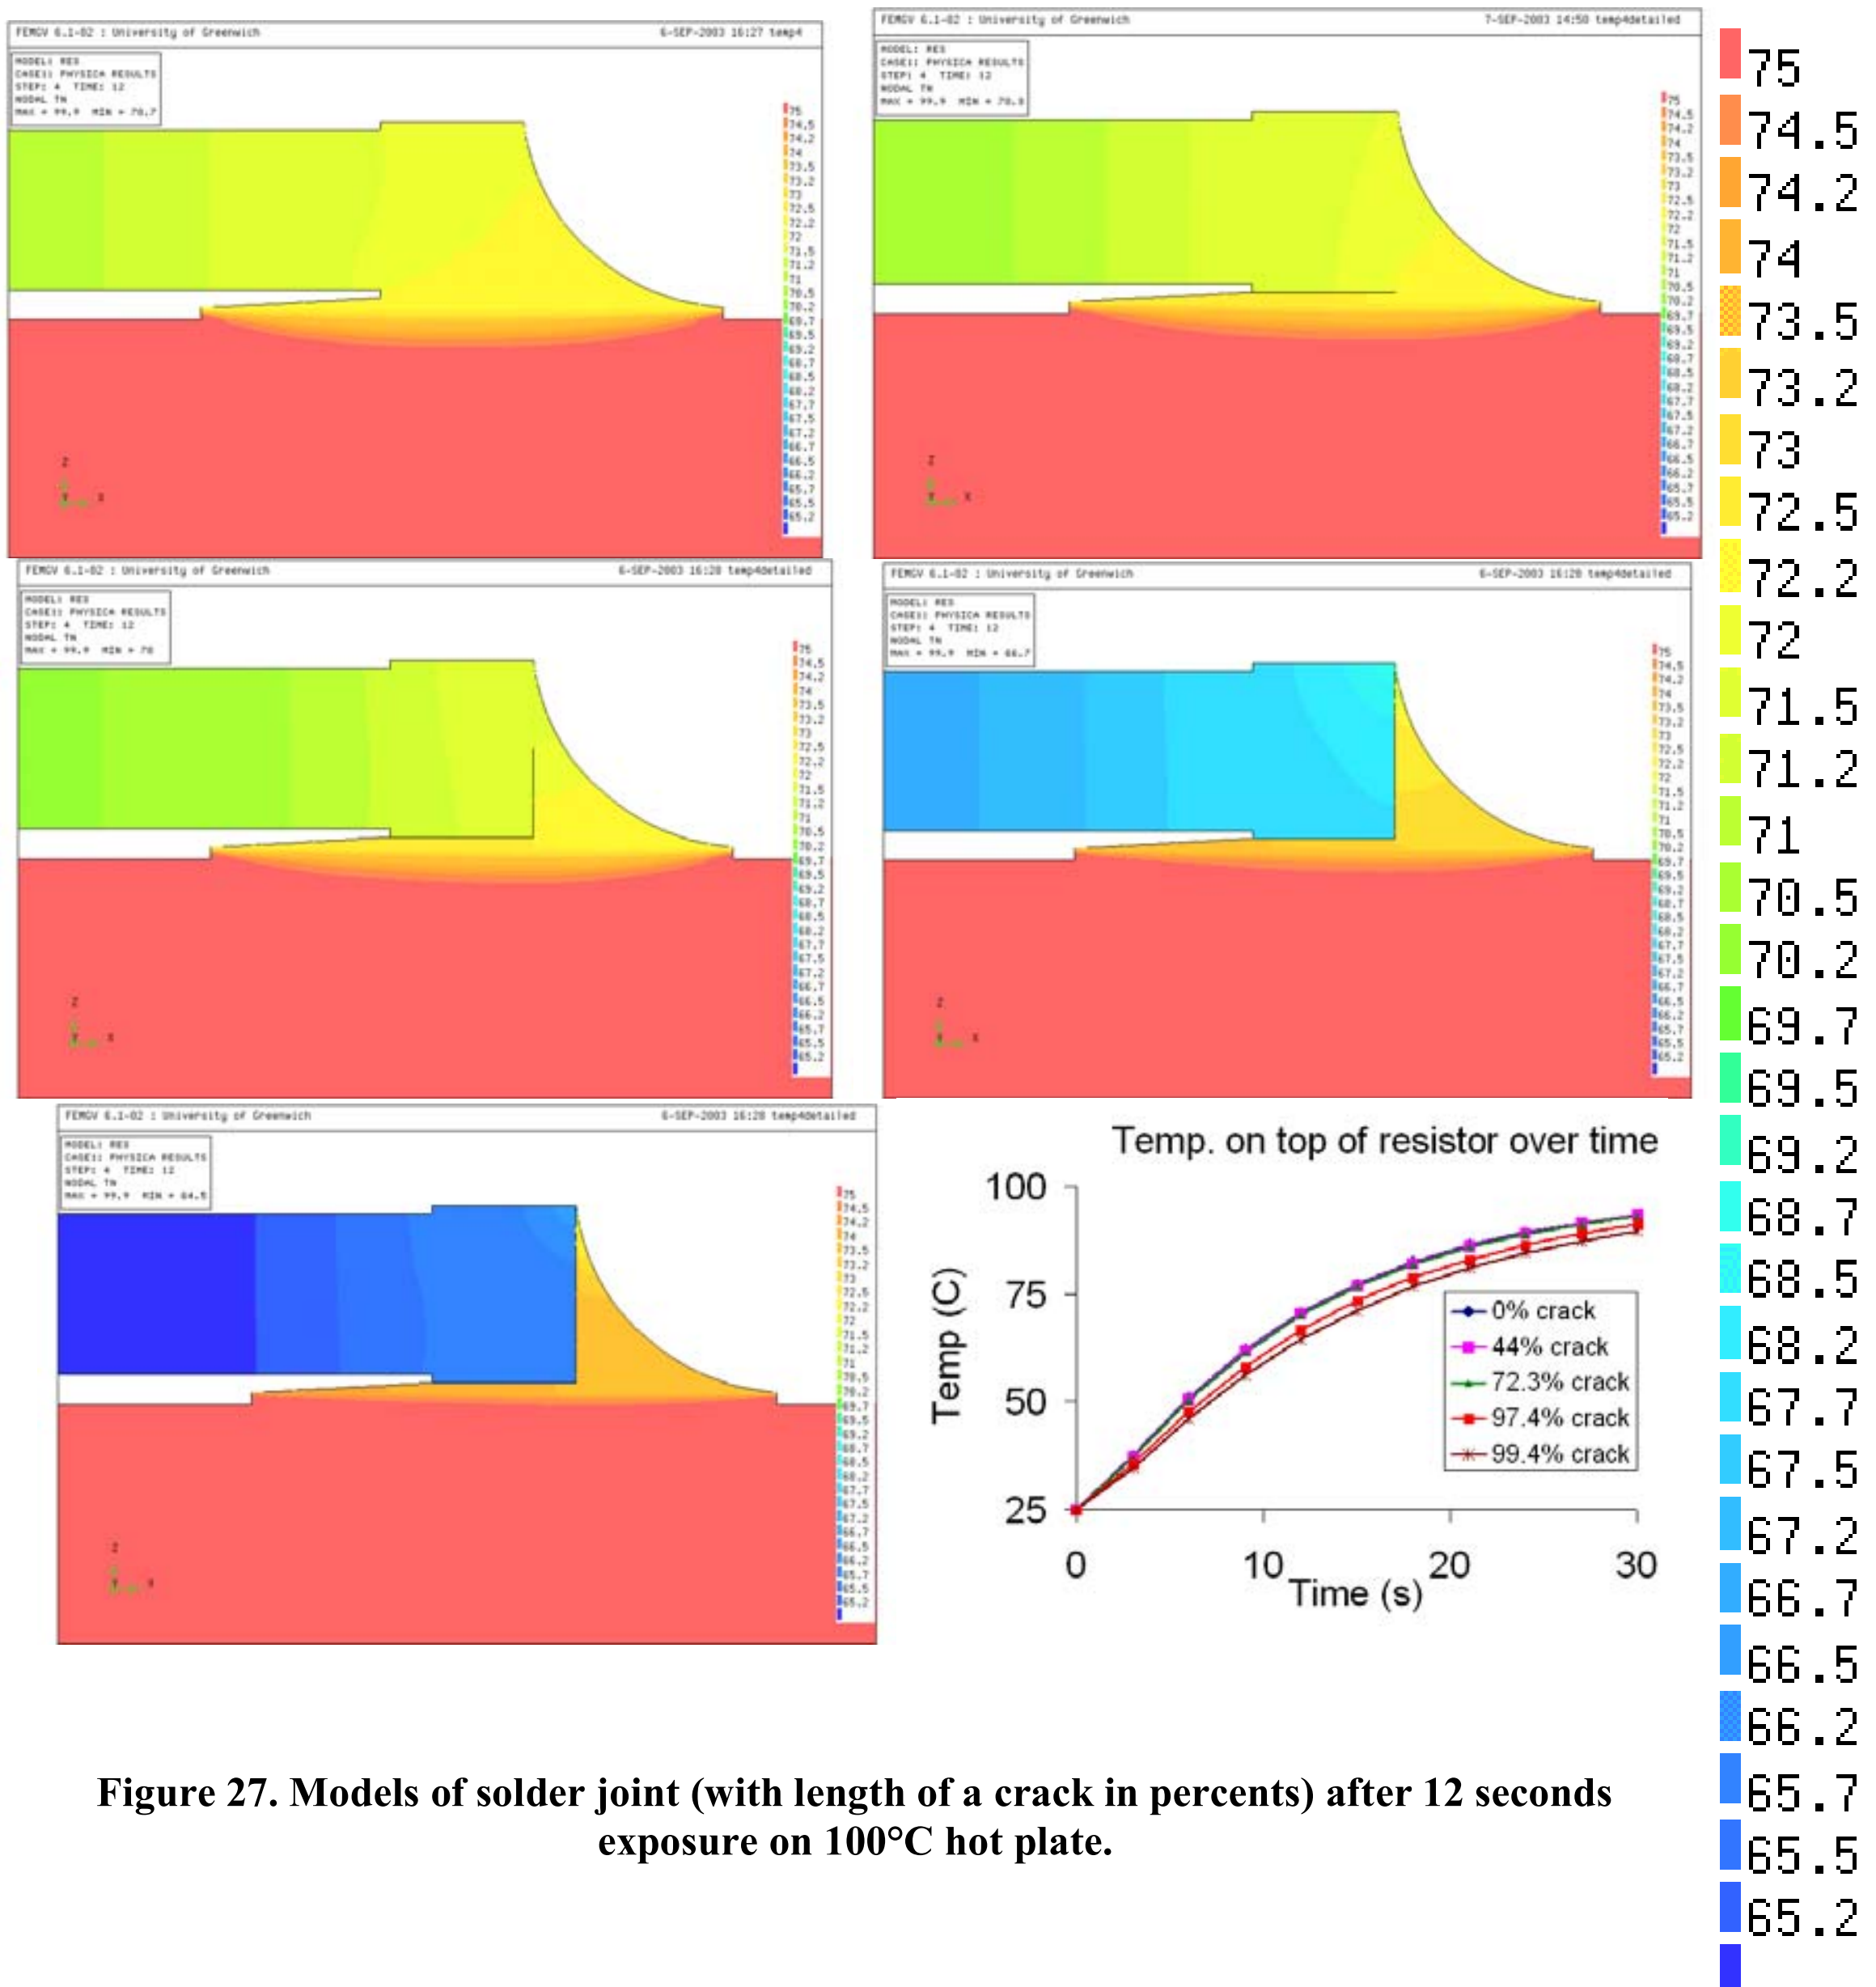
Results from the FEA analysis are presented in Figures 27 A-E, which show solder joints with a range of cracks following heat exposure. The length of each crack is indicated in percentage terms; the 0% crack represents the uncycled, uncracked state, whilst the 100% crack is equal to the length of the resistor termination. Temperatures are indicated by the colours, and the simulations (A-E) were stopped after 12 seconds of heat exposure. It is clear from simulations A to C that there is no significant difference in temperature distributions over the heating up period and hence it is concluded that the size of the crack does not affect the thermal conductivity of the solder joint.

Figure 27. Models of solder joint (with length of a crack in percents) after 12 seconds exposure on 100°C hot plate.

Figure 27 F shows how the temperature increased in time in respect of each crack. The only significant changes in the dynamics of heat transfer occur when the length of the crack is between 72 and 97% of the termination length. However, it is expected that solder joints with cracks of this scale will already be failing mechanically. These results confirm the unsuitability of this testing method in crack assessment.
